Manhole Inspection Summary

Manhole # S21E1_019MH

Location Address: **2651 huron st** Cross Street: **harman-banger alley**

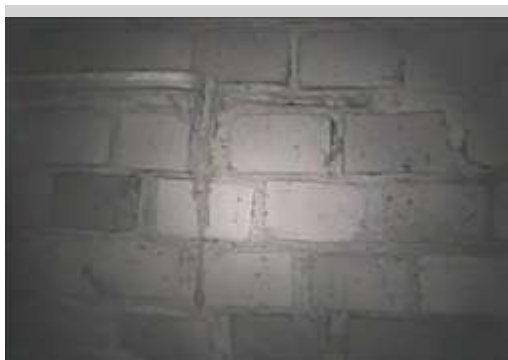
Defect 1

Surcharge ☒ **Evidence Of Surcharge** Depth: **3** (ft.) ☐ Active Surcharge Present

bench debris

surcharge evidence

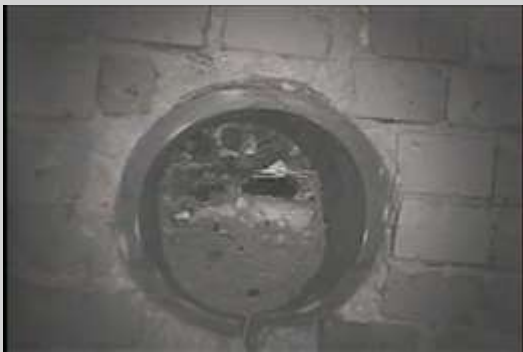
12 O'Clock Inflow

0 in. Circular Gravity Sewer
Pipe In @ 12 O'Clock

Connects To: **Stub connection / abandoned**

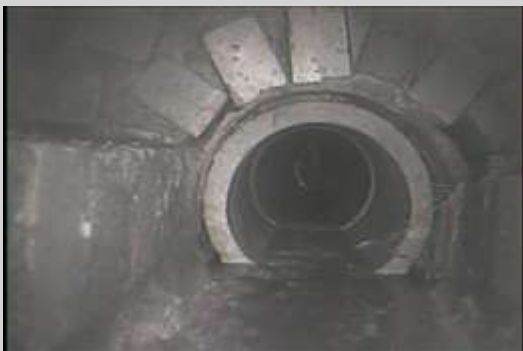
12 O'Clock Outflow

8 in. Circular Gravity Sewer
Pipe Out @ 12 O'Clock

Infiltration: **None** Pipe Seal Cond: **Broken**

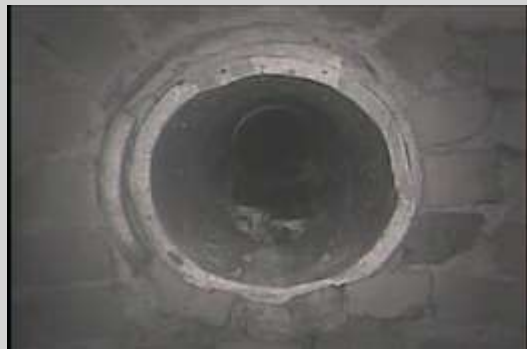
Pipe In @ 6 OClock

8 in. Circular Gravity Sewer

Deposits: ☐ None ☐ Mud ☐ Sludge ☐ Debris ☒ **Grease**

Silt Depth: **2** (in.) Deposits Extent: **Light**

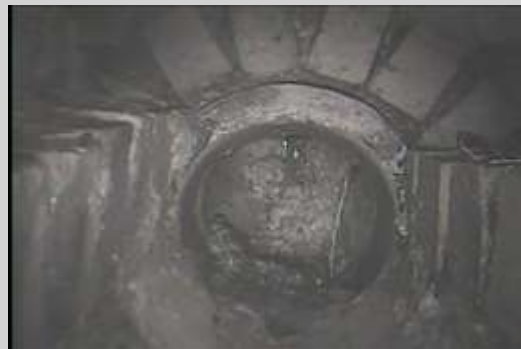
Drop In @ 6 OClock

Drop: **Outside** Rod and Bar

Drop Condition: **Partly Clogged**
